Main Relay

Fixing your PGM-Fi Main Relay.

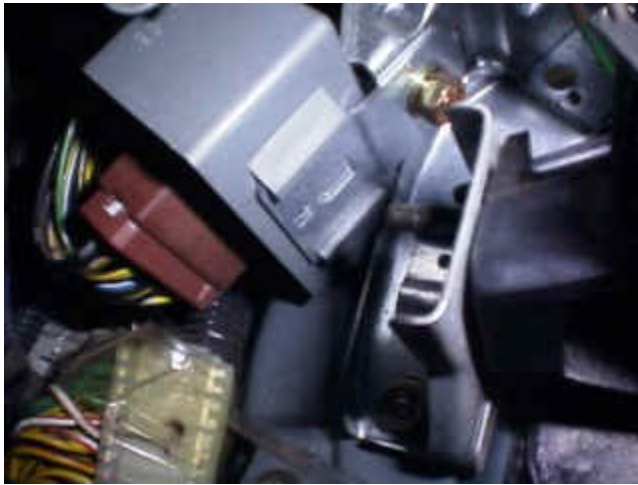
The main relay is usually located in the fuse box area, and you basically can't miss it. The picture above shows the location in a Civic VTi saloon. In the MK2 CRX and MK4 Civic, it is in a more restricted location, [click here](#) to get a more detailed view. Remove the 10mm mounting bolt, and then depress the latch on the connector, and pull to remove.

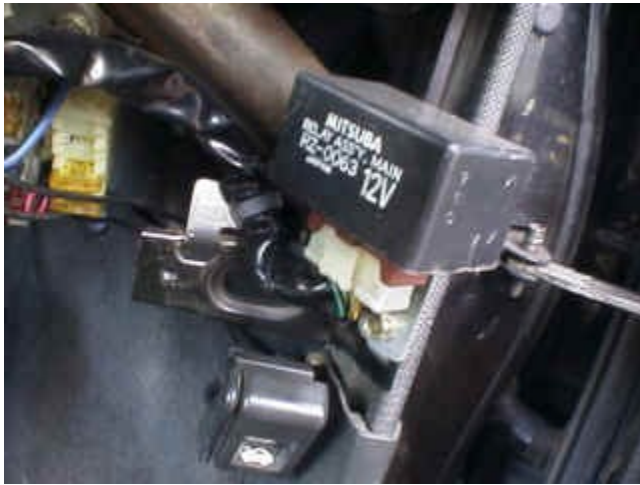
Here is a shot of where the main relay is mounted in the MK3 CRX and MK4 Civic. I took this picture when had the dashboard out for another reason - note you do not have to remove the dashboard to get to the relay, just remove the bonnet release lever and the coin holder.

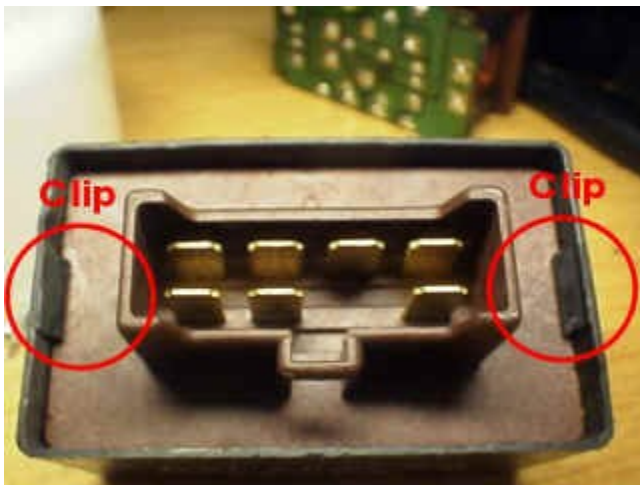
To remove the cover from the relay, you need to bend back the clips on the cover that hold it in place. This can be done with gentle pressure without any tools at all, though it is sometimes easier to unclip one side at a time with a fine screwdriver.

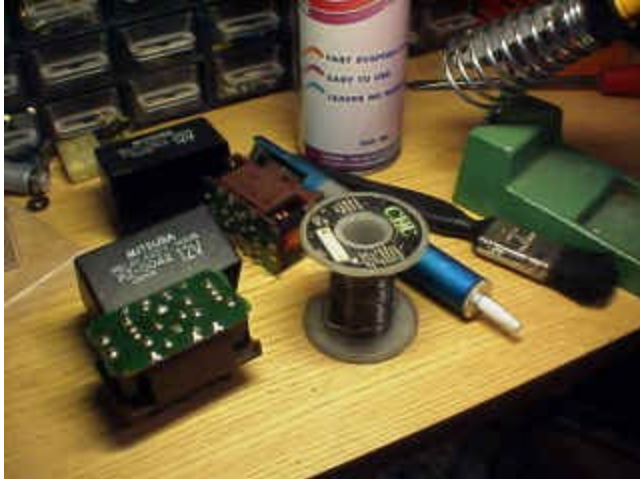
Here are the tools that you'll need

- Soldering iron
- IPA Solvent (or equivalent to remove flux)
- Brush to help remove the flux with the above
- Good quality 60/40 solder
- Soldering iron

As it is only the soldering at fault, you just have to re-solder the faulty joints, but would strongly recommend that ALL of the joints on the PCB be re-soldered. I won't tell you how to solder here, as if you can't then get someone that knows to do it, otherwise you could end up damaging the PCB. One thing I will say that the most common problem many people encounter when soldering is using too much heat. This repair job can easily be performed with a 15 watt iron, and certainly don't use a soldering gun. Use a light, electronic duty soldering iron, of no more than 25 watts. Also use a good quality electronic grade solder.

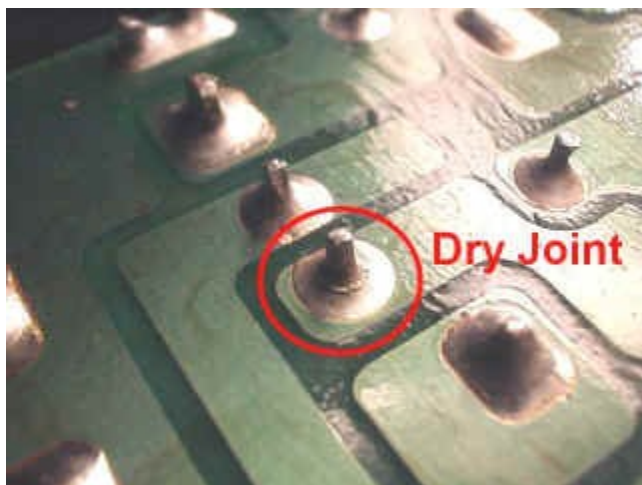
A dry joint in the PGM-FI main relay, causing an intermittent or no connection. This relay controls power to the ECU, and the fuel pump. With no power to the rest of the fuel-injection system, or fuel pump, you won't be going anywhere!

Here is what a dry joint looks like. You can see the crack in the solder between the pin and PCB track. Notice the others are OK. Most of the time it is the same joints that fail in the relay, but de-solder and re-make every joint in the relay when you are repairing it. Dry joints are caused by vibration and changes in temperature cracking the solder round a joint which has not flowed correctly. They have a characteristic look, and sometimes are very hard to spot, even to a trained eye. Remember, it is not the actual relay itself that is at fault, just the soldering.

- Remove the relay
- Remove the cover
- Remove solder from ALL joints
- Re-solder all joints
- Clean the flux residue from the PCB
- Spray on conformal coating
- Replace the cover
- Re-Install in vehicle
